# Test Report

**Test Item:** ALERTA Transit  
Manual, folding, transit wheelchair

**Test** ISO 7176-19:2008 as amended by  
EN 12183:2014

**Millbrook Report No.** 17/1184

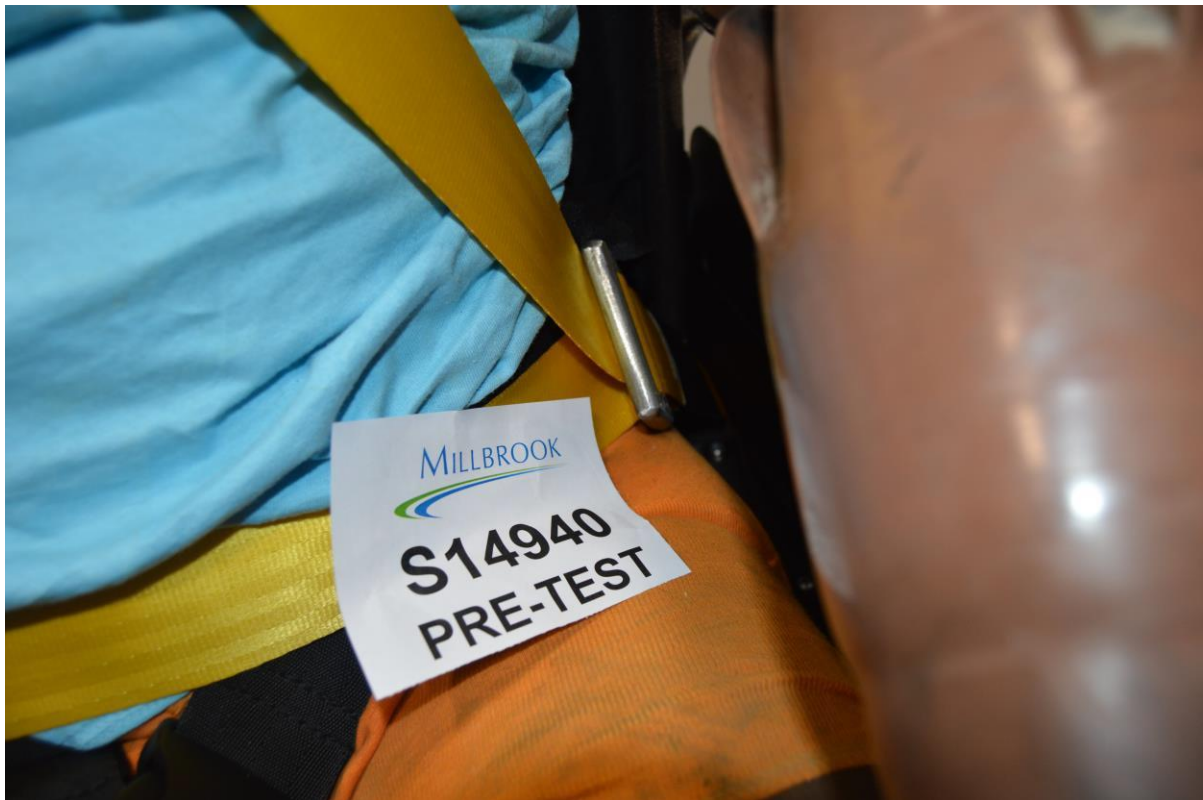
Note 1: Lap belt routing under arm support and skirt guard required to achieve effective location of lap belt.

Lap belt position, pre-test

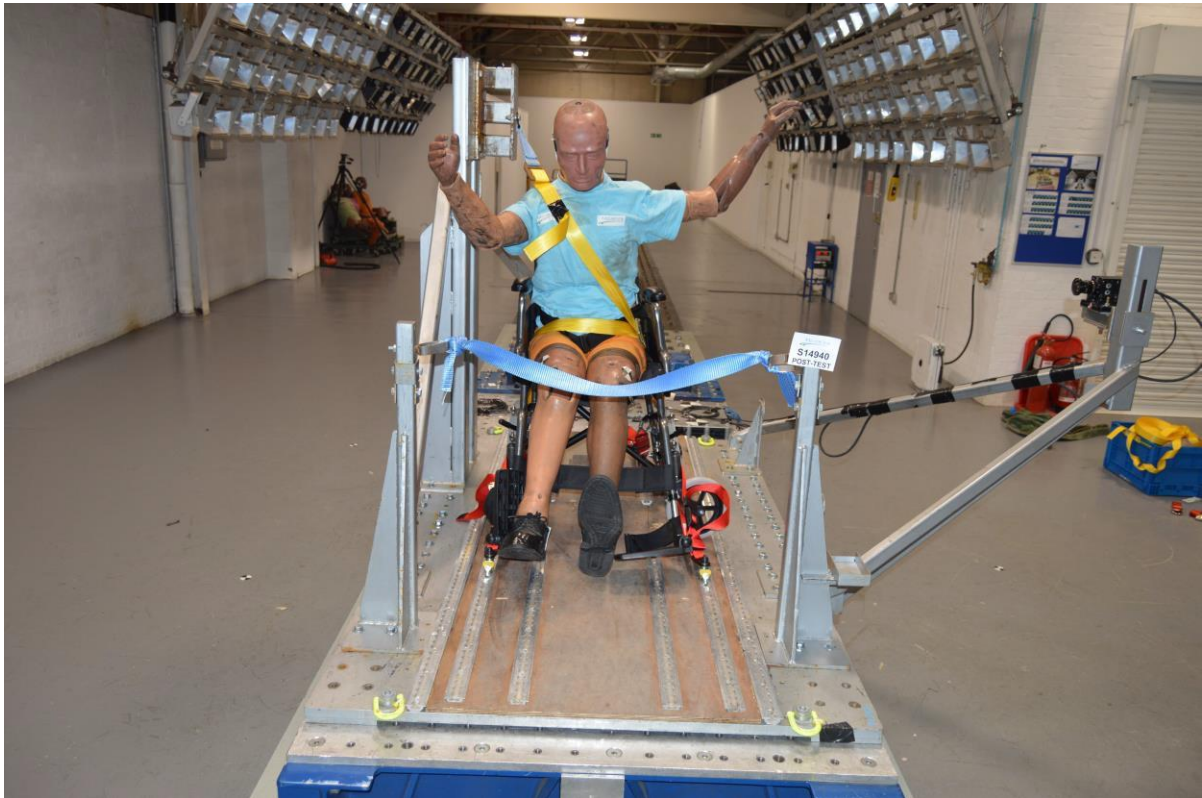
Front view, post-test

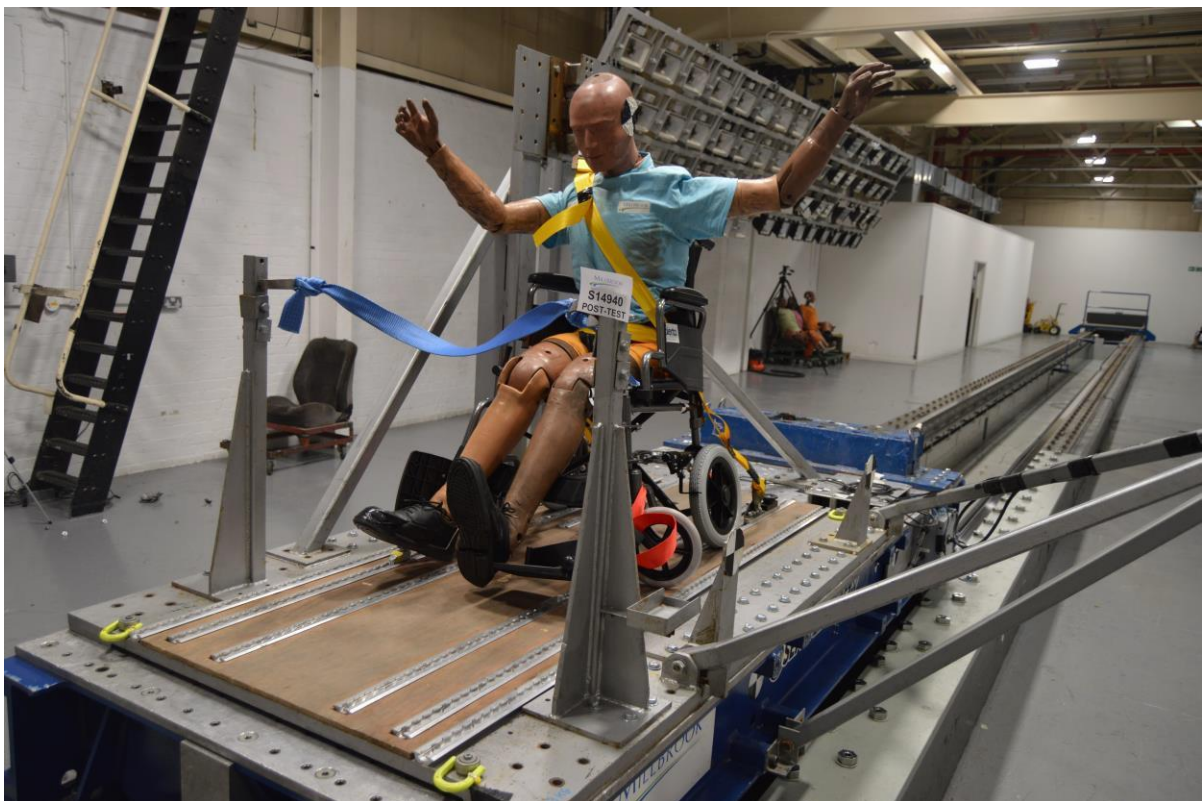
Front  $\frac{3}{4}$  view, post-test

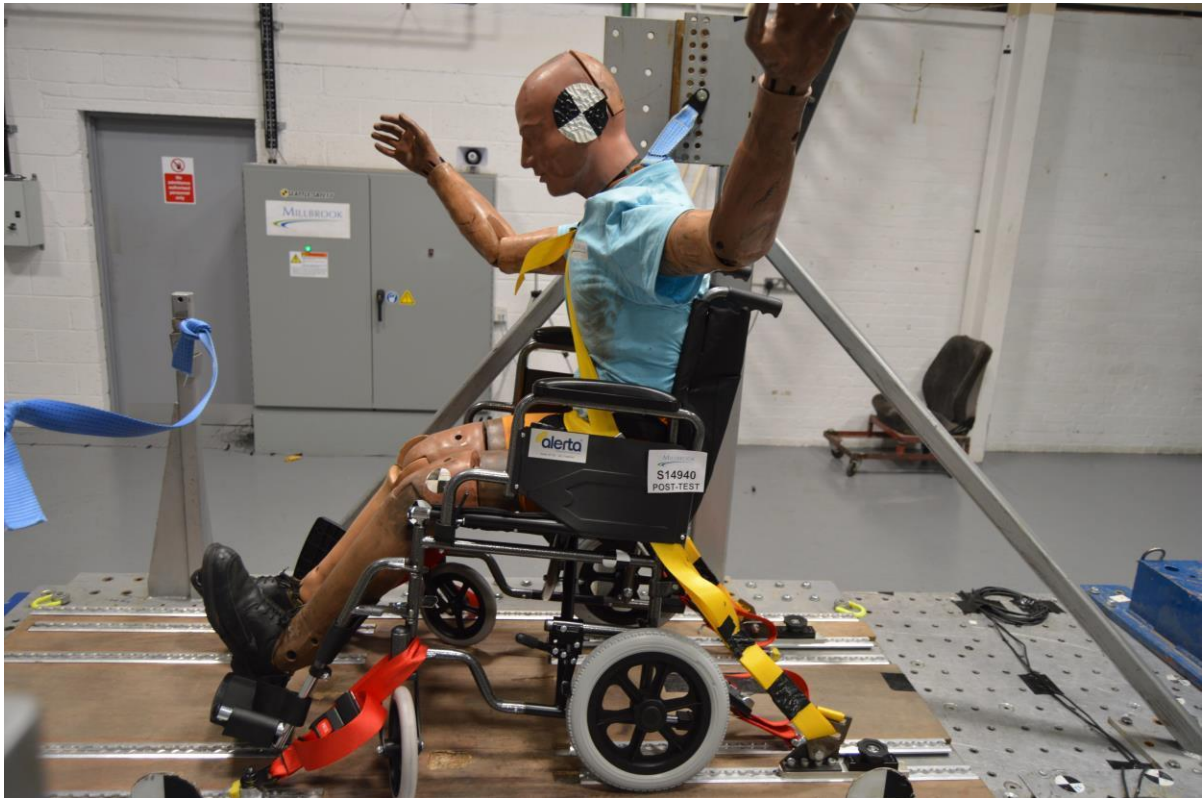
LH view, post-test

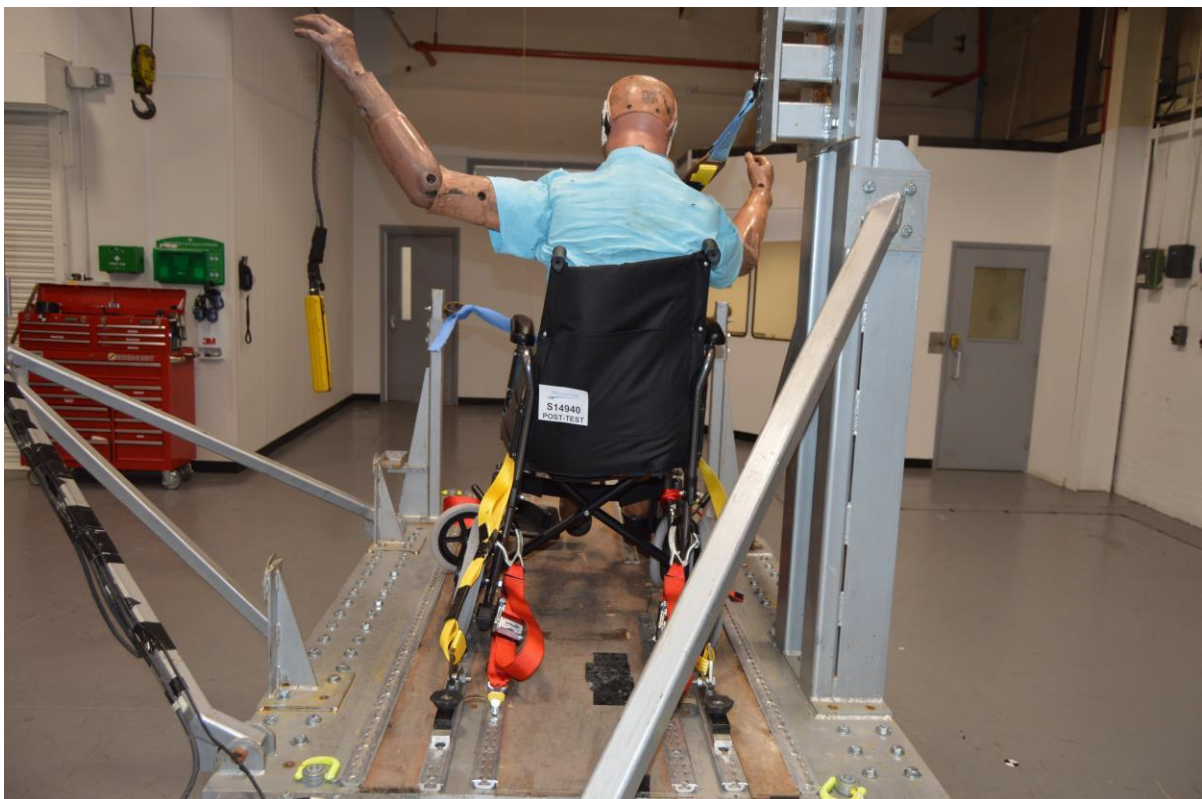
Rear view, post-test

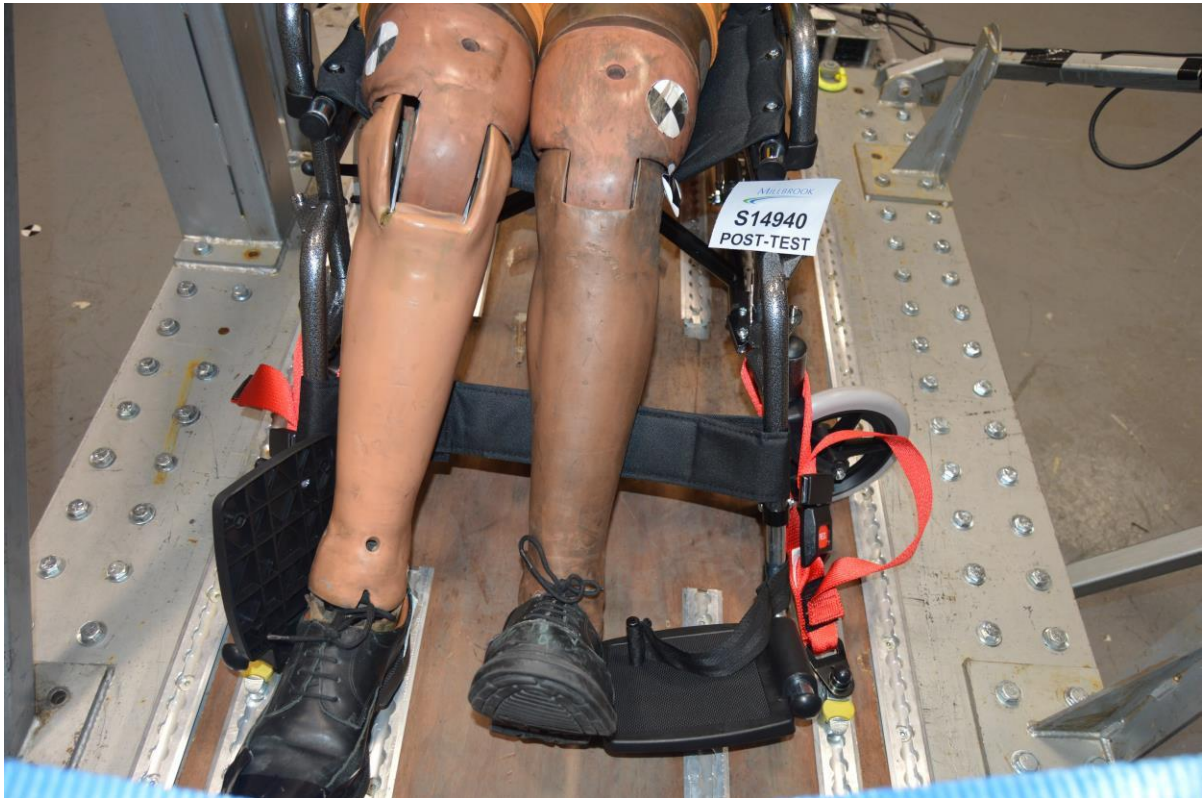
Front tie-downs, post-test

b) Did the wheelchair securement points show visible signs of material failure	Pass
c) Did any components of a mass greater than 100g become detached from the wheelchair	Pass

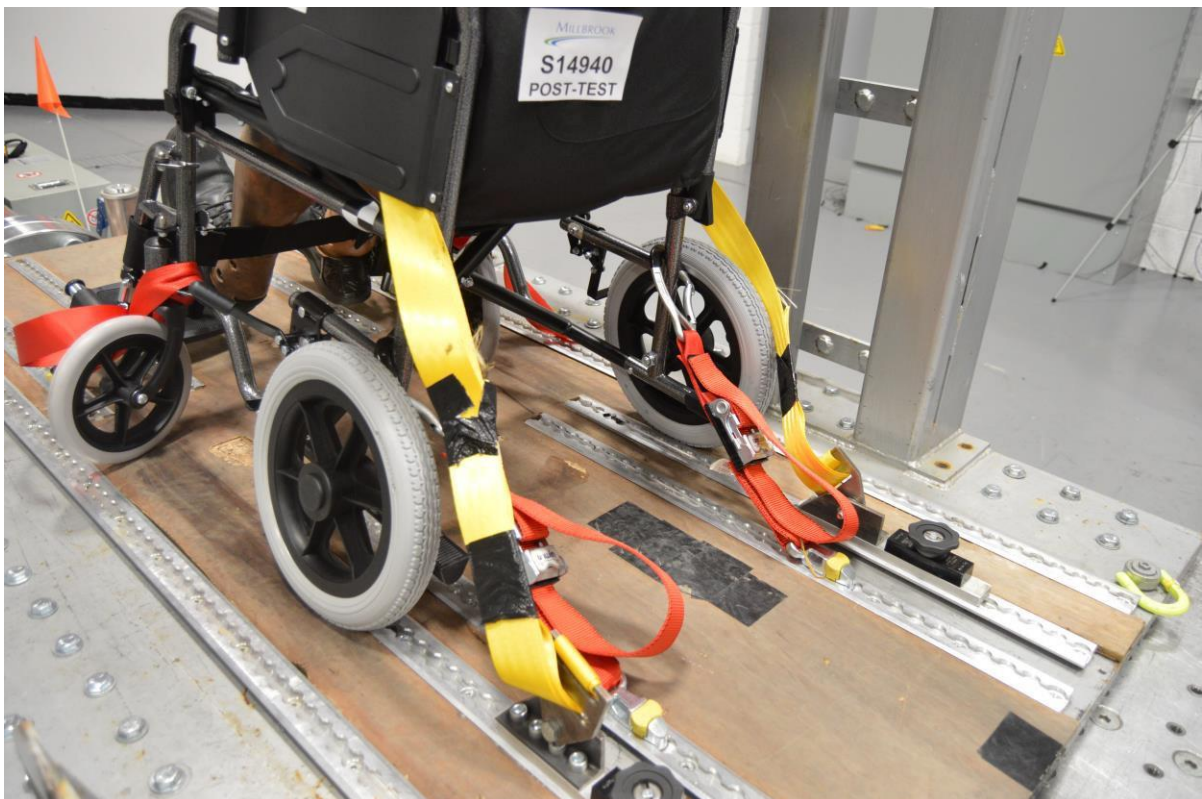
Rear tie-downs, post-test

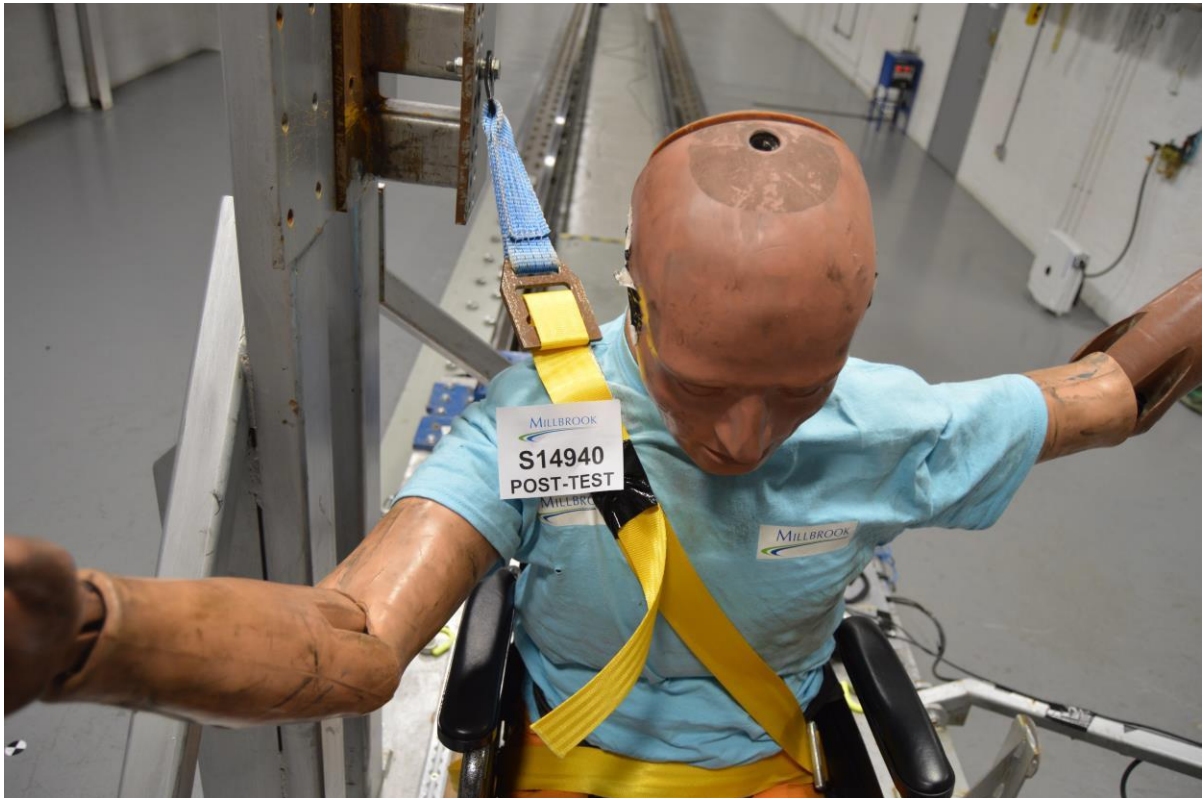
Occupant restraint upper anchorage point, post-test
